A.C.E. Home Inspection Service

Inspector Name: Tim Knight, ASHI Member 202490
Inspection No: 12121212
Inspection Date: 1/1/2012
Client: John Doe
Address: 1234 Sample Dr.
Sample, MO 61212

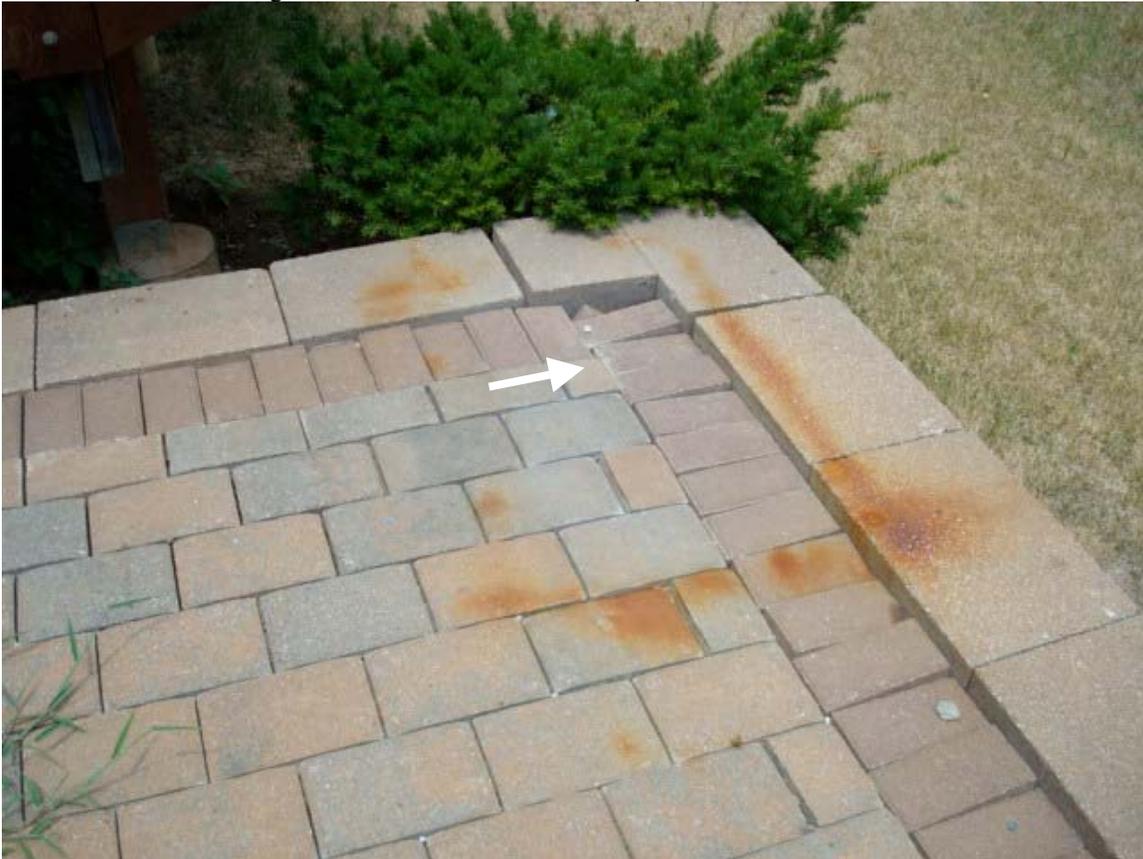
Concrete. Brick. Settling noted on the at the rear brick patio.

Settling noted on the at the rear brick patio.

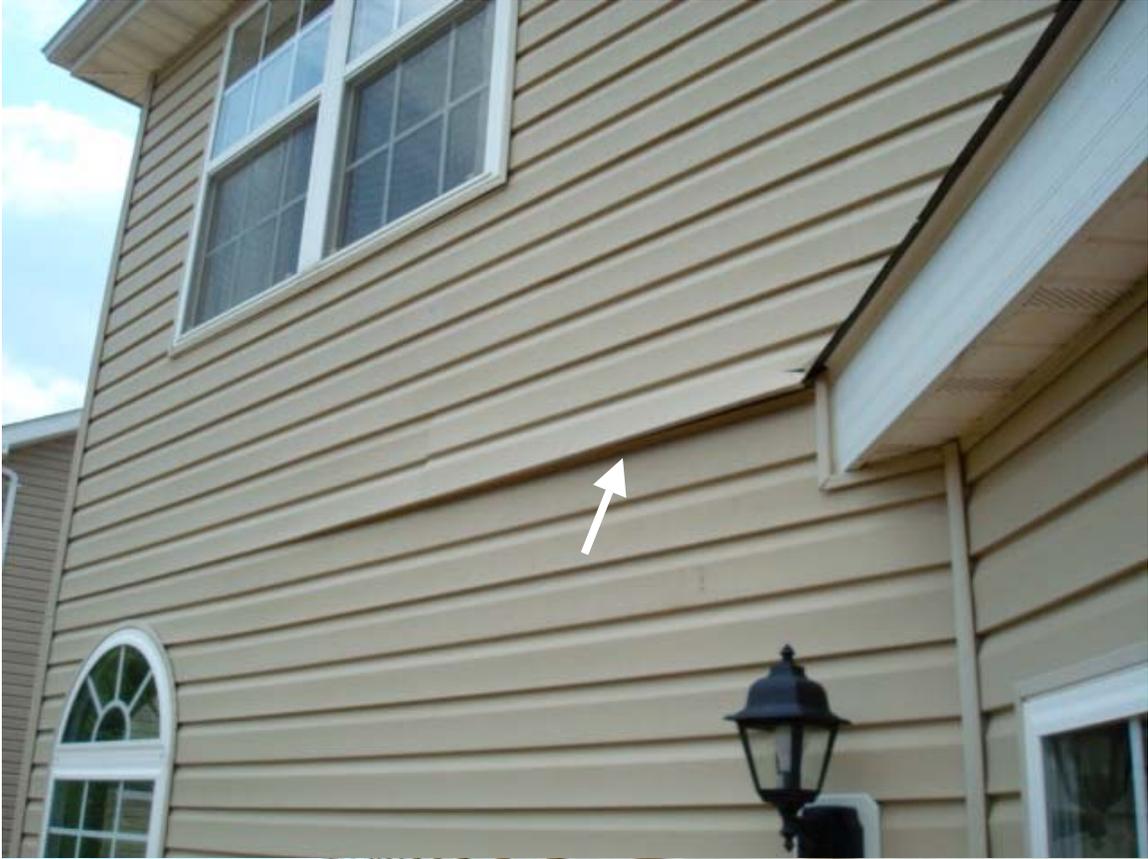
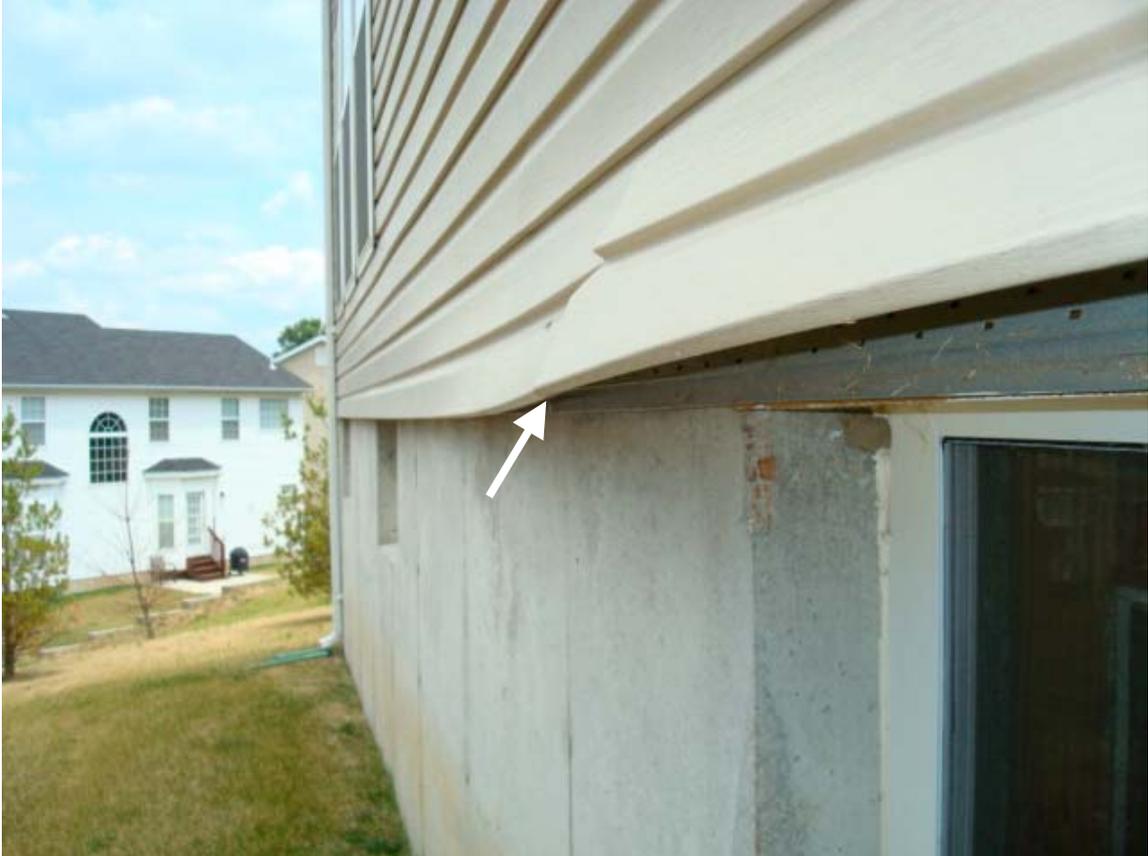
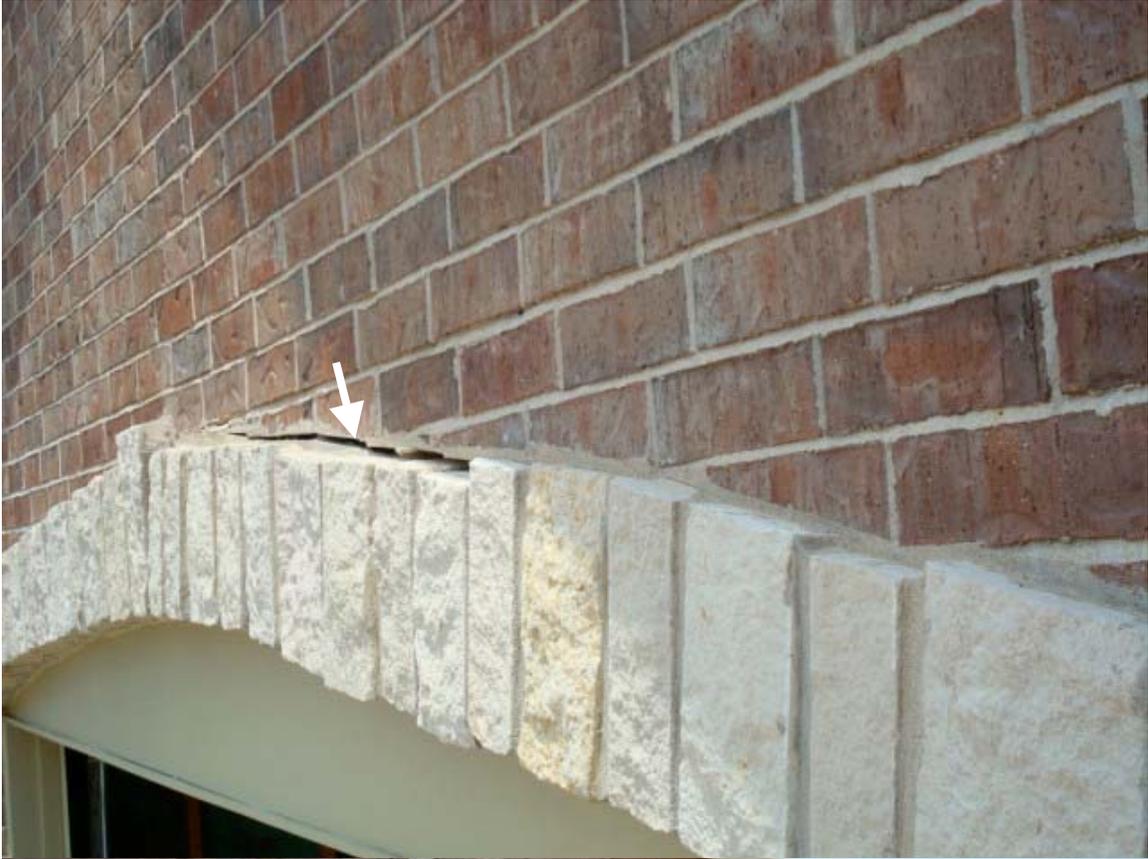
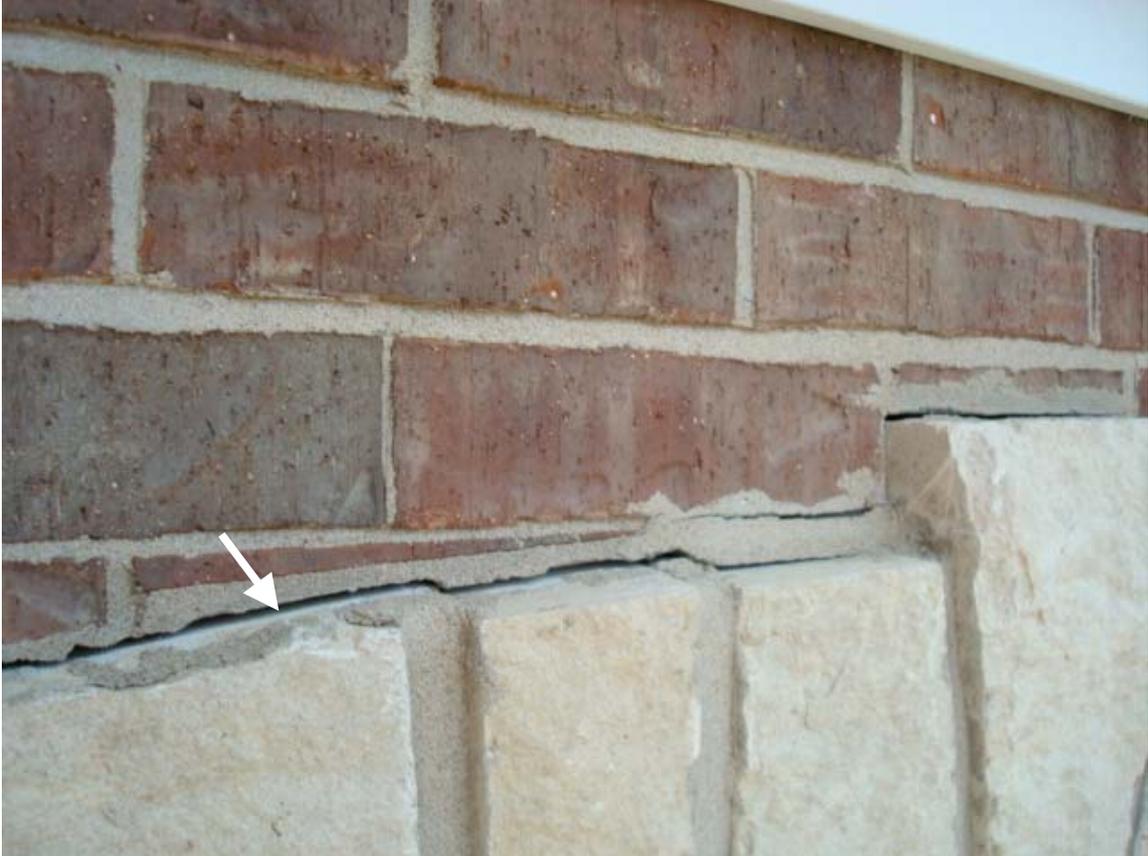
Stone siding. Vinyl siding. Brick siding. Recommend caulking as needed as a maintenance effort. Loose vinyl siding panels noted at the rear and left sides of the house, recommend securing loose siding as needed. The brick and stone siding above both garage doors is cracked and settled. Recommend replacing the loose stones and damaged brick as needed. Recommend review/repair as needed by a licensed siding contractor.

Recommend caulking as needed as a maintenance effort. Loose vinyl siding panels noted at the rear and left sides of the house, recommend securing loose siding as needed. The brick and stone siding above both garage doors is cracked and settled. Recommend replacing the loose stones and damaged brick as needed. Recommend review/repair as needed by a licensed siding contractor.

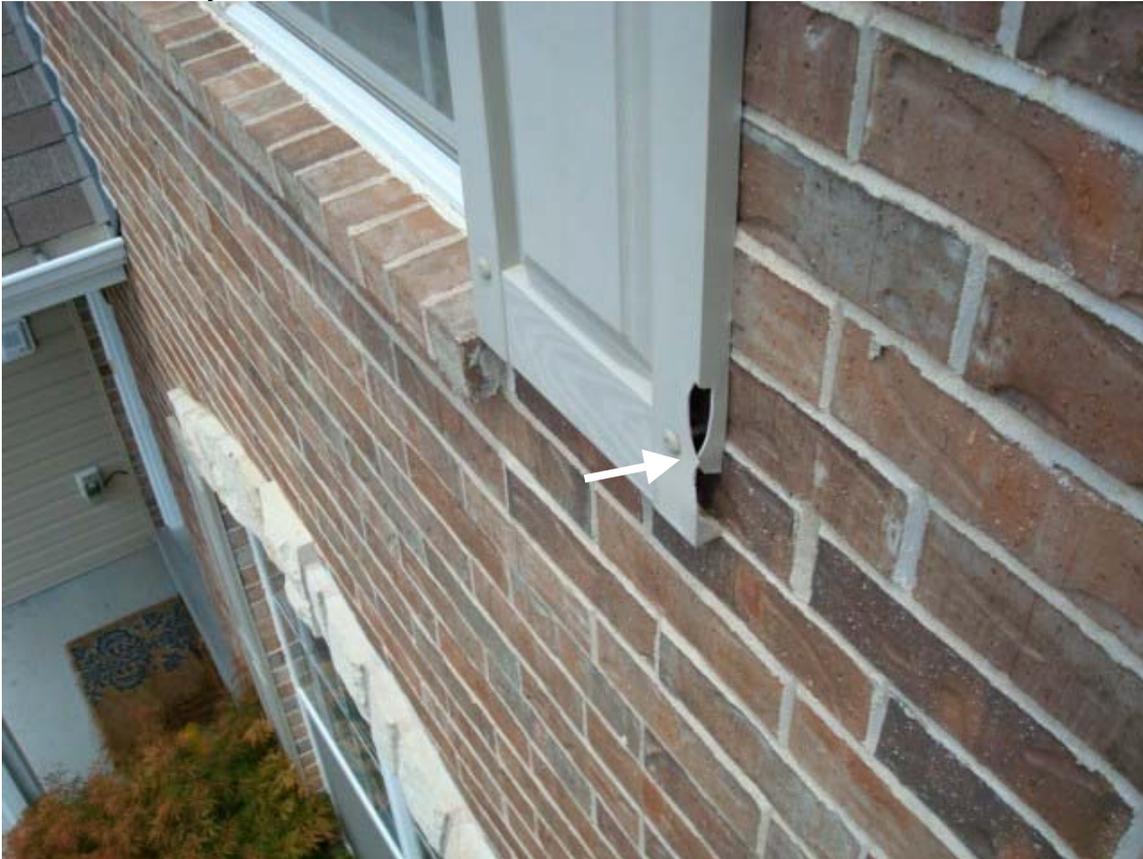
Torn/damaged screens noted. Hole noted in one front shutter, recommend replacing the damaged shutter as needed. Recommend review/repair as needed by a licensed contractor.

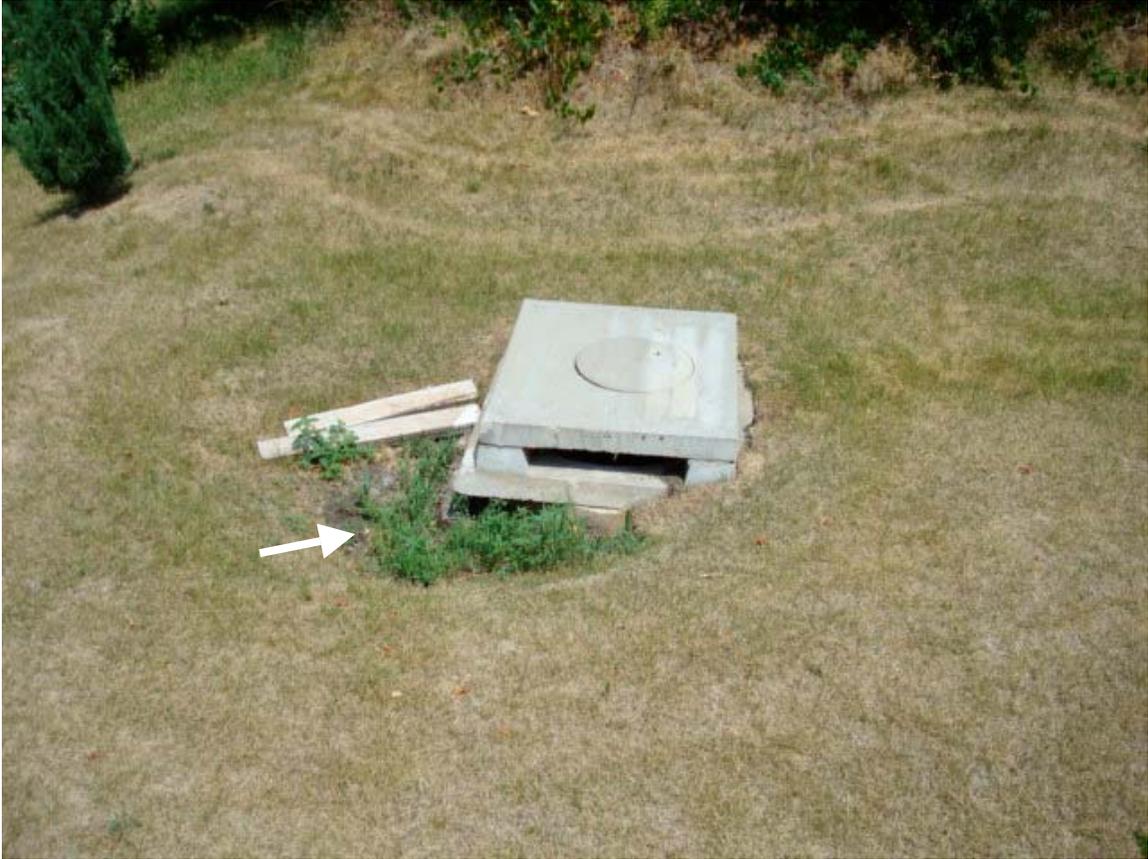
The ground around the storm drain in the rear yard is settled, recommend repairing as needed. Recommend contacting the local municipality for review and repair as needed.

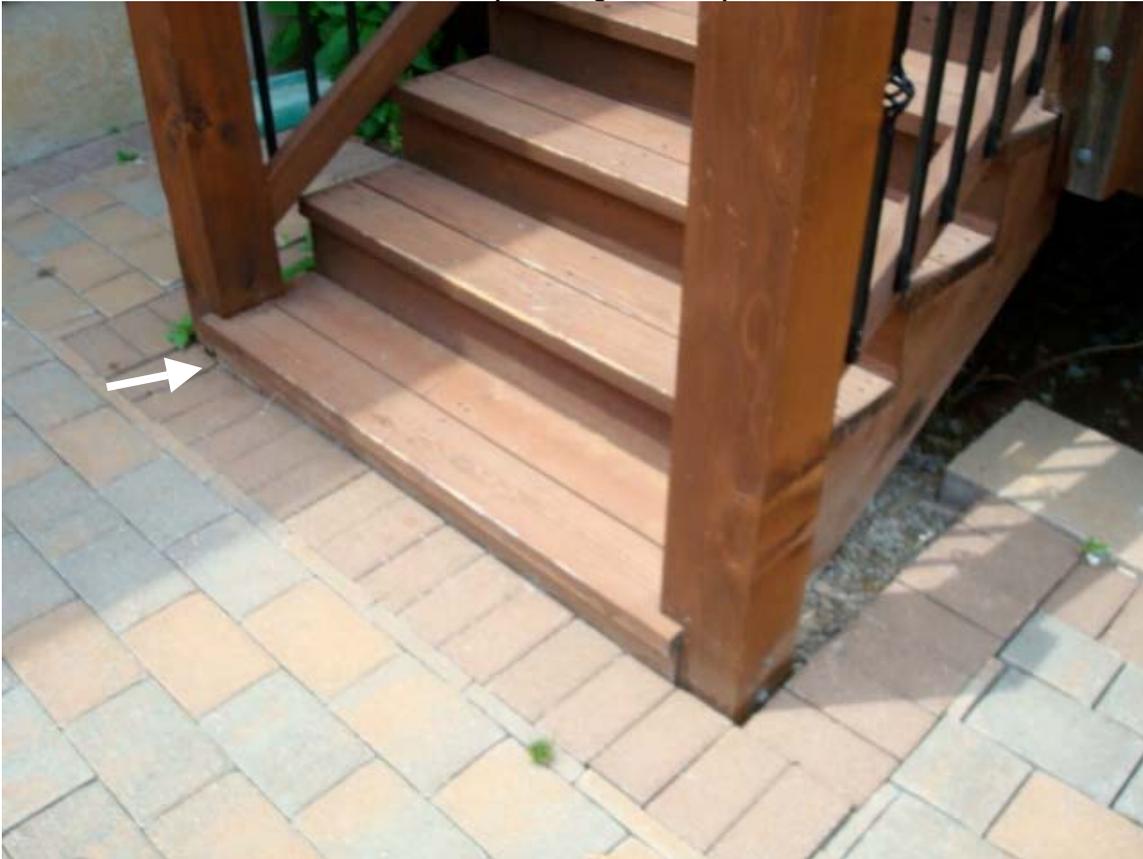
Wood. Earth to wood contact noted on the shorter stairs, this can cause wood to deteriorate. Recommend providing concrete pad for treads.

Earth to wood contact noted on the shorter stairs, this can cause wood to deteriorate. Recommend providing concrete pad for treads.

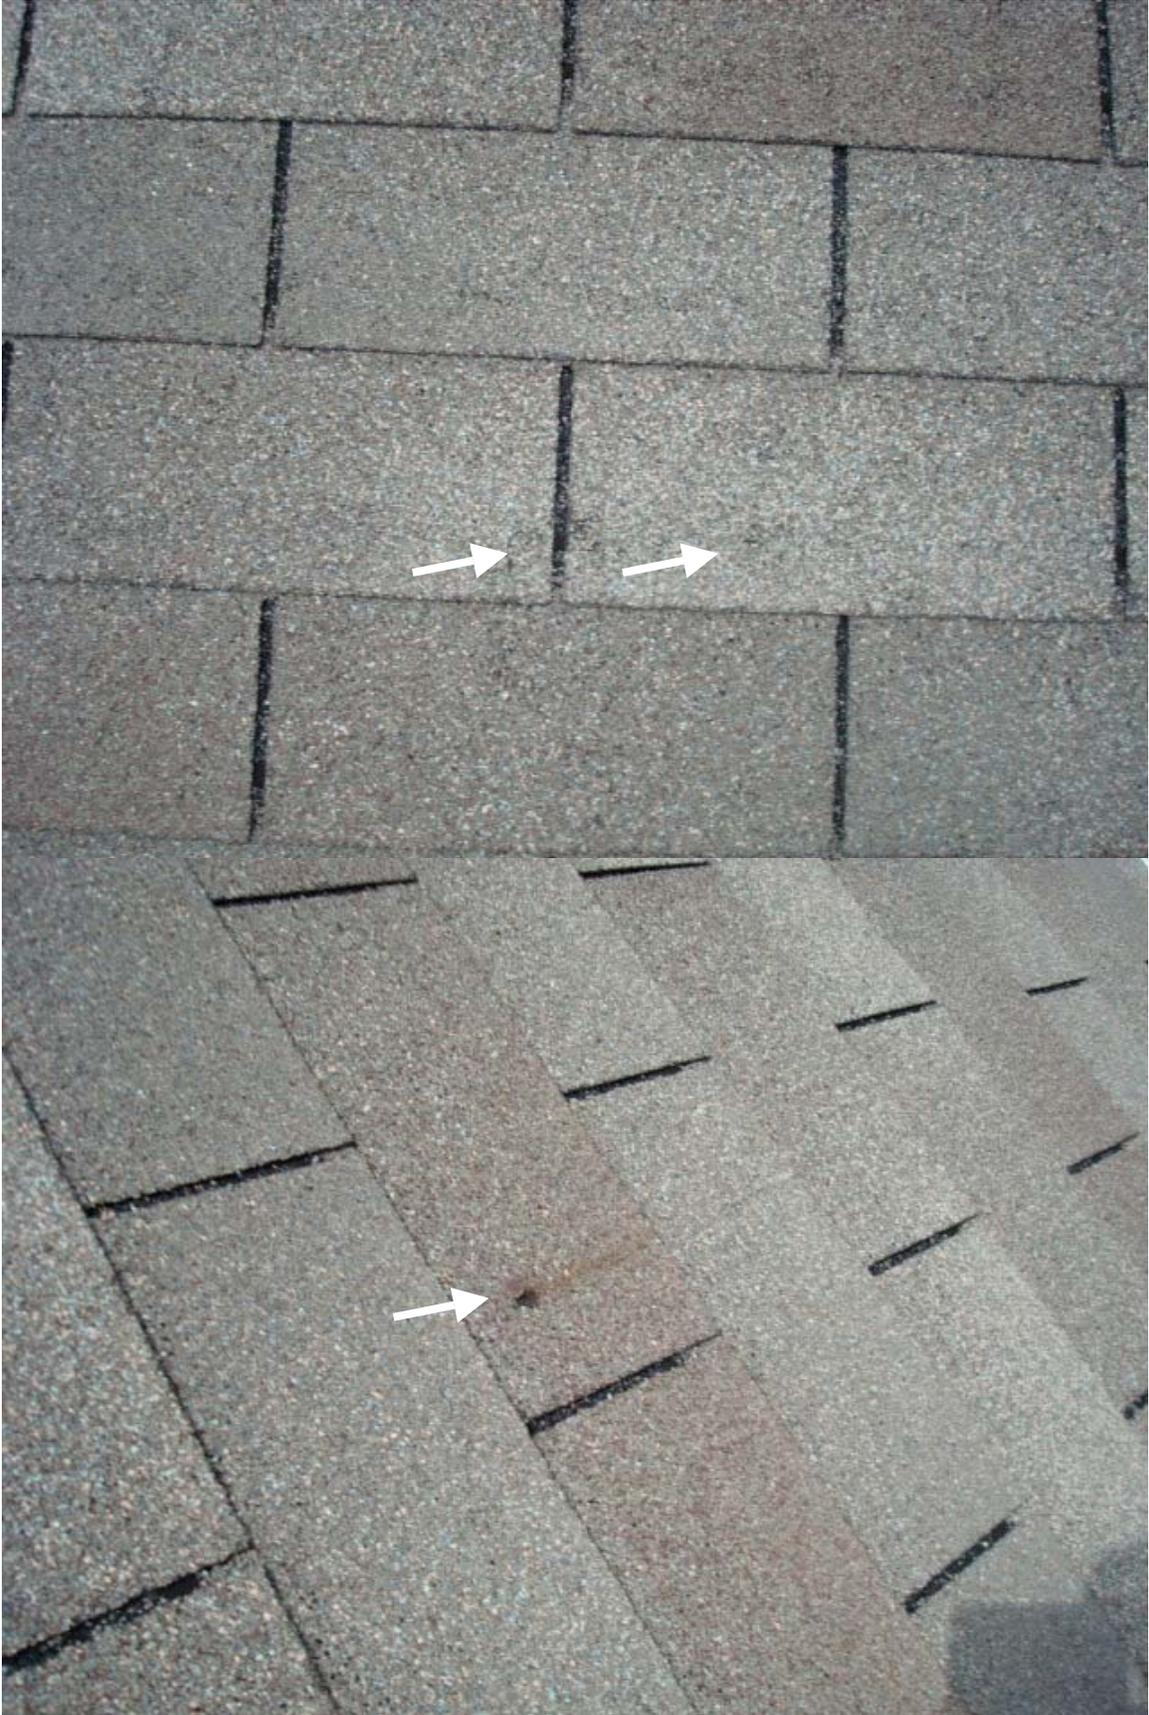
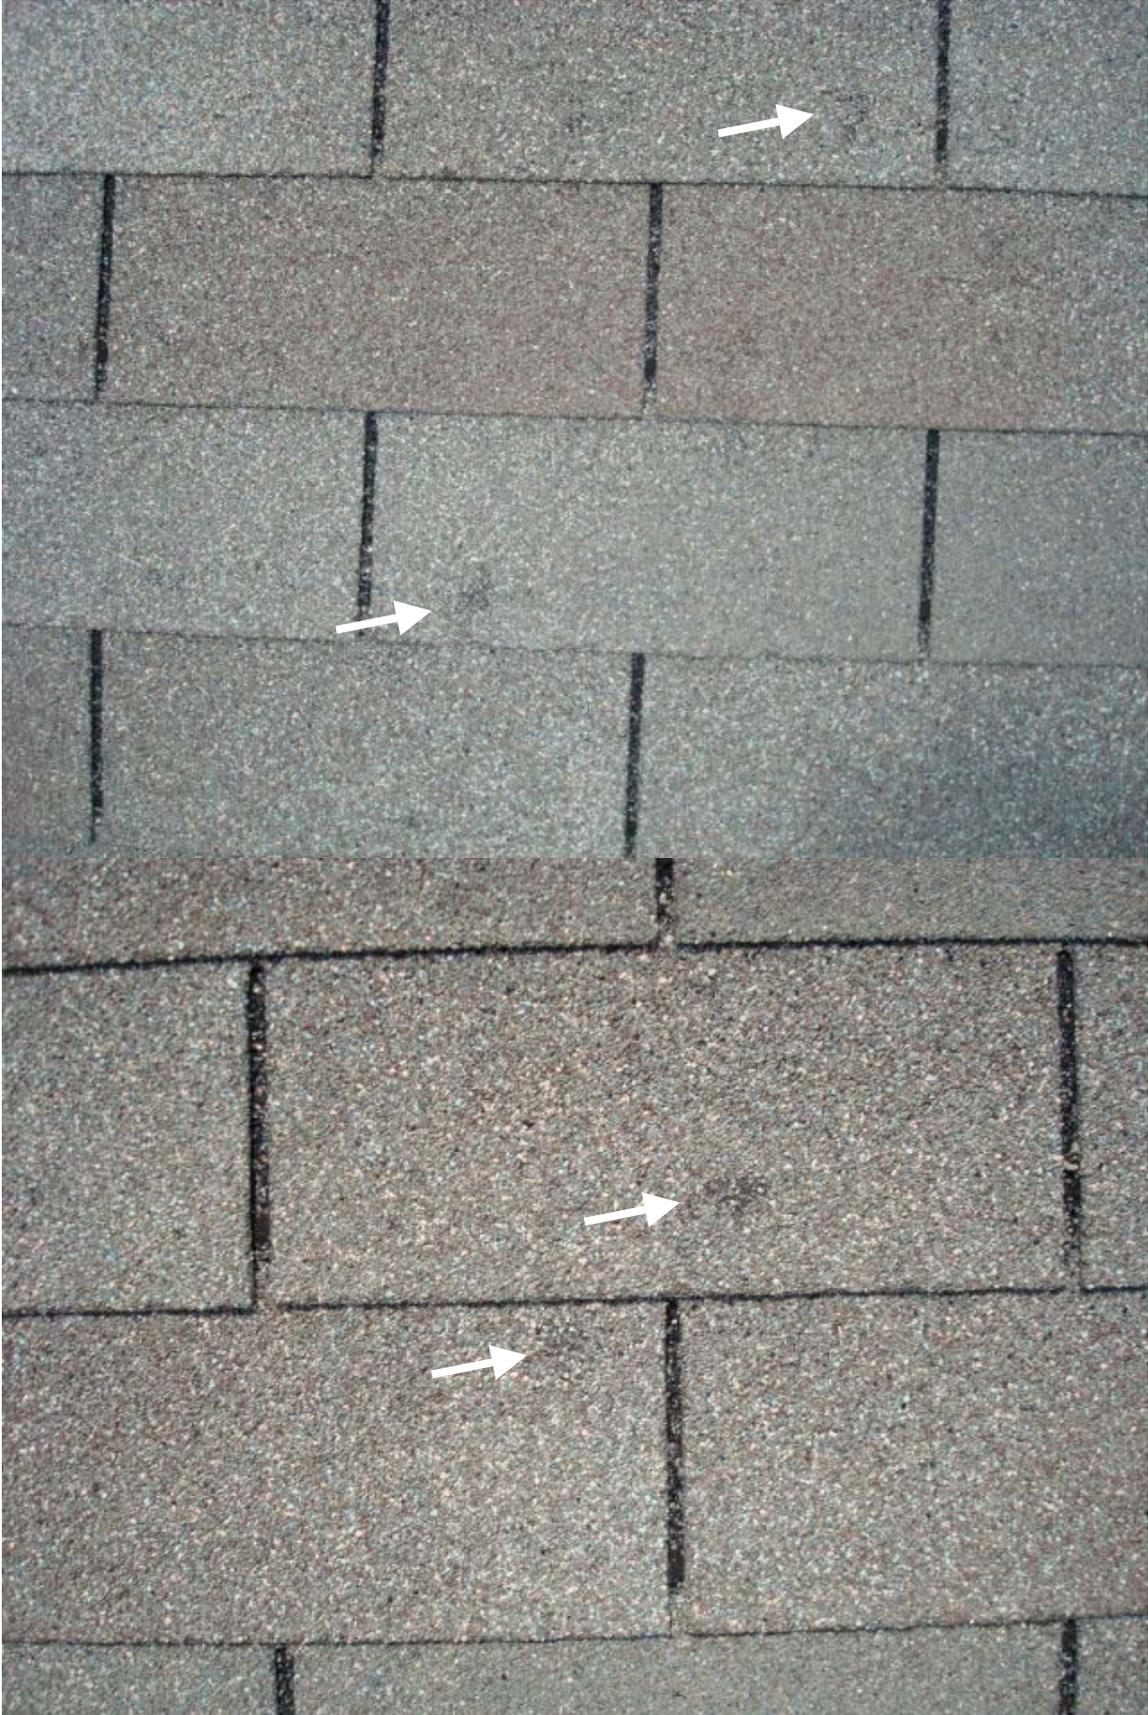
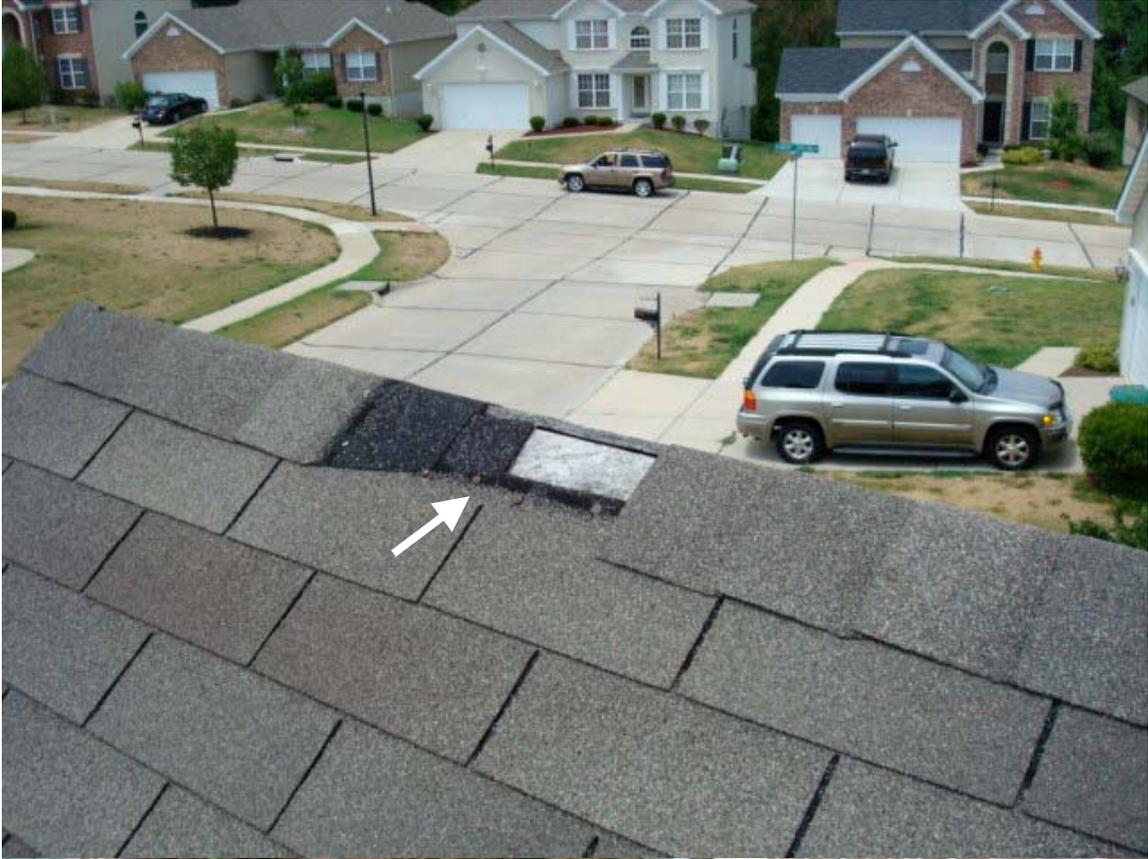
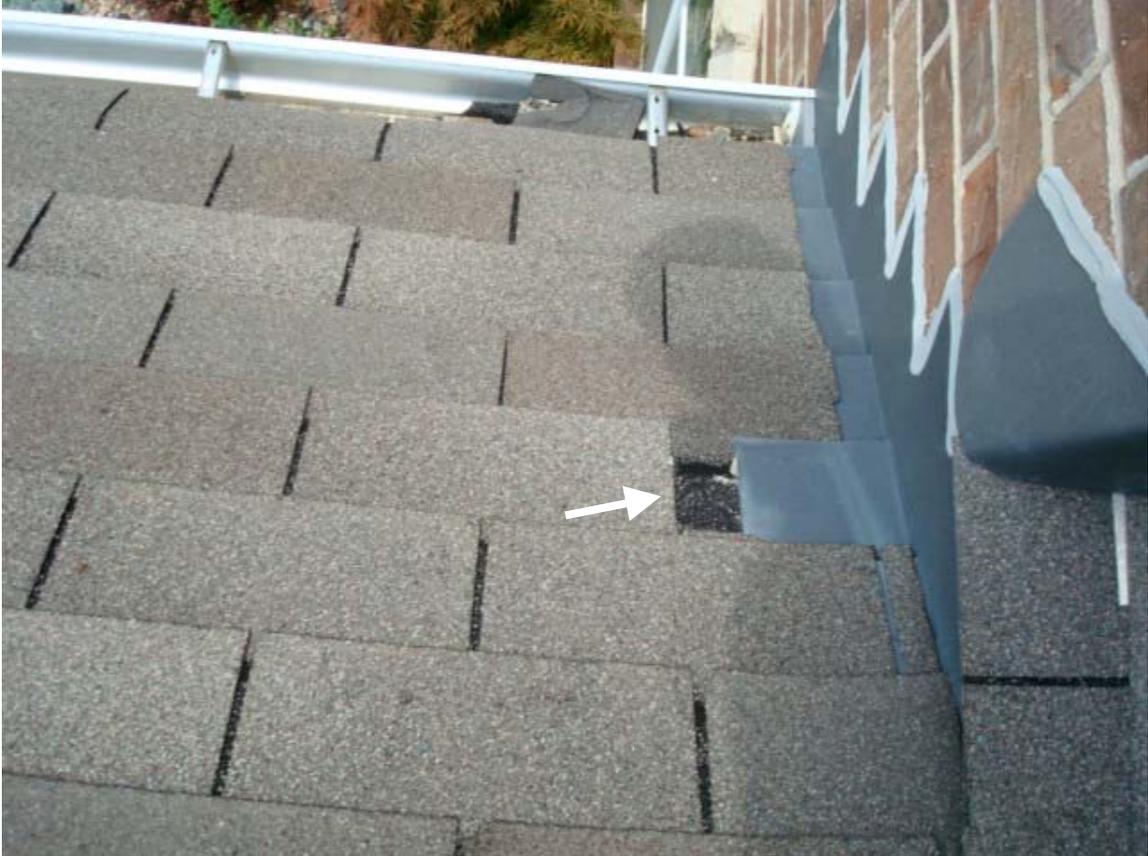
Roof was visually inspected from all accessible areas. Roof appears to be a single layer covering. The average life span for a roof of this type is 15-20 years. Roof does show signs of wear (Hail pockmarks and loss of granule material) Missing shingles noted at two places at the garage roof. Recommend replacing missing shingles as needed. Recommend review/repair as needed by a licensed roofer.

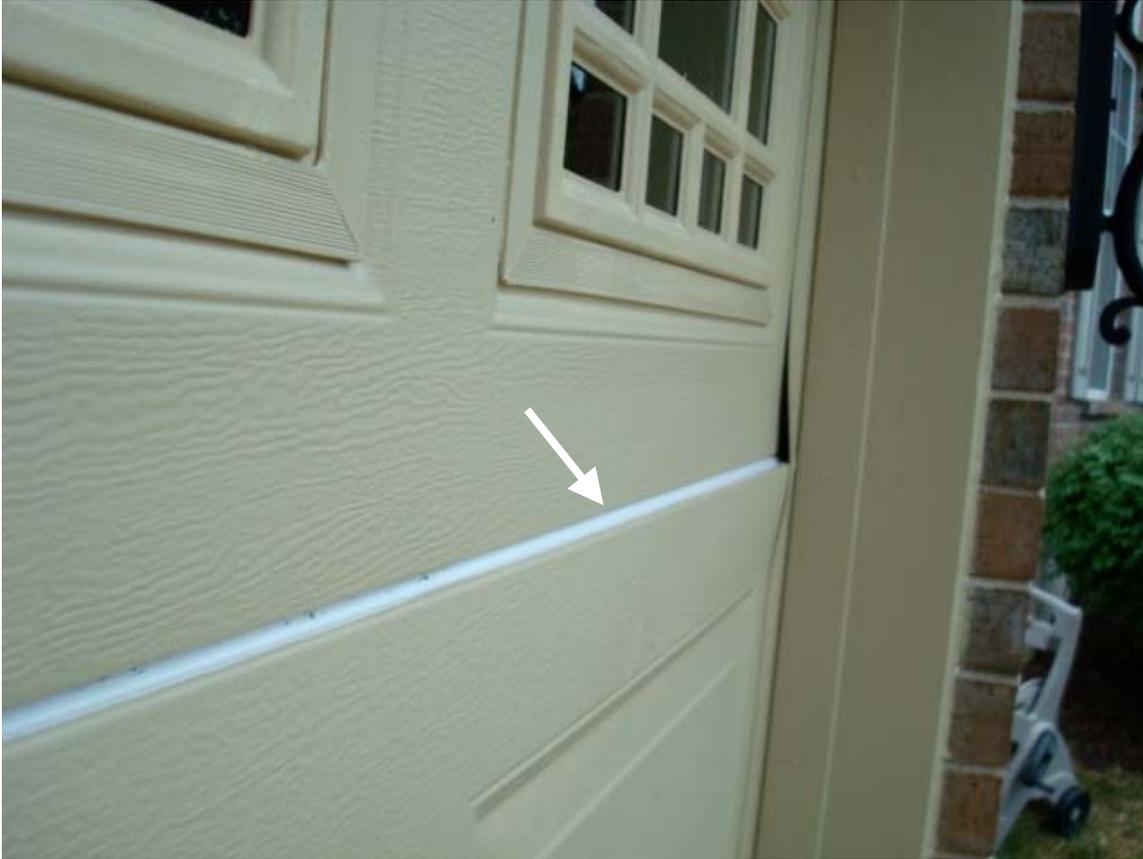
Metal. Safety springs installed as a safety feature. The small garage door binds up and the panels misalign, recommend repairing the small garage door as needed.

The small garage door binds up and the panels misalign, recommend repairing the small garage door as needed. Recommend review/repair as needed by a licensed contractor.

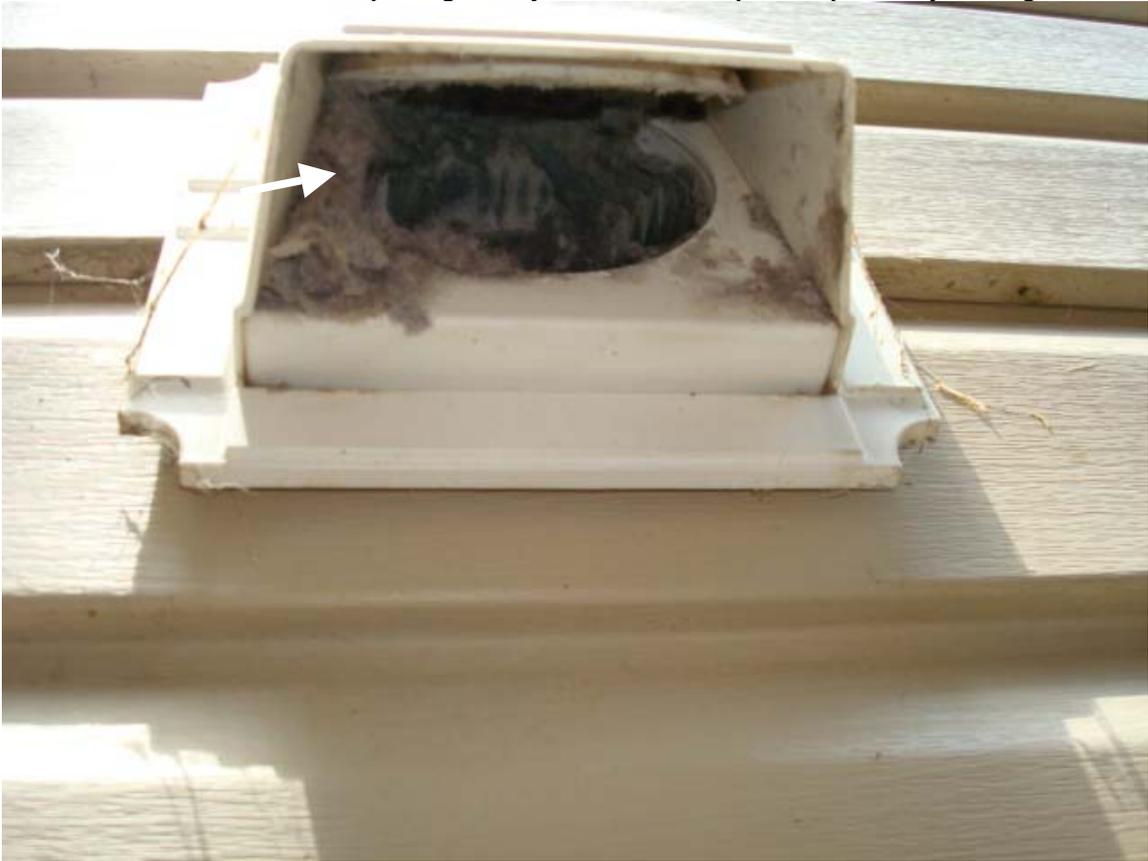
Recommend replacing the dryer vent cover to prevent pest entry/nesting. Heat source present.

Recommend replacing the dryer vent cover to prevent pest entry/nesting.

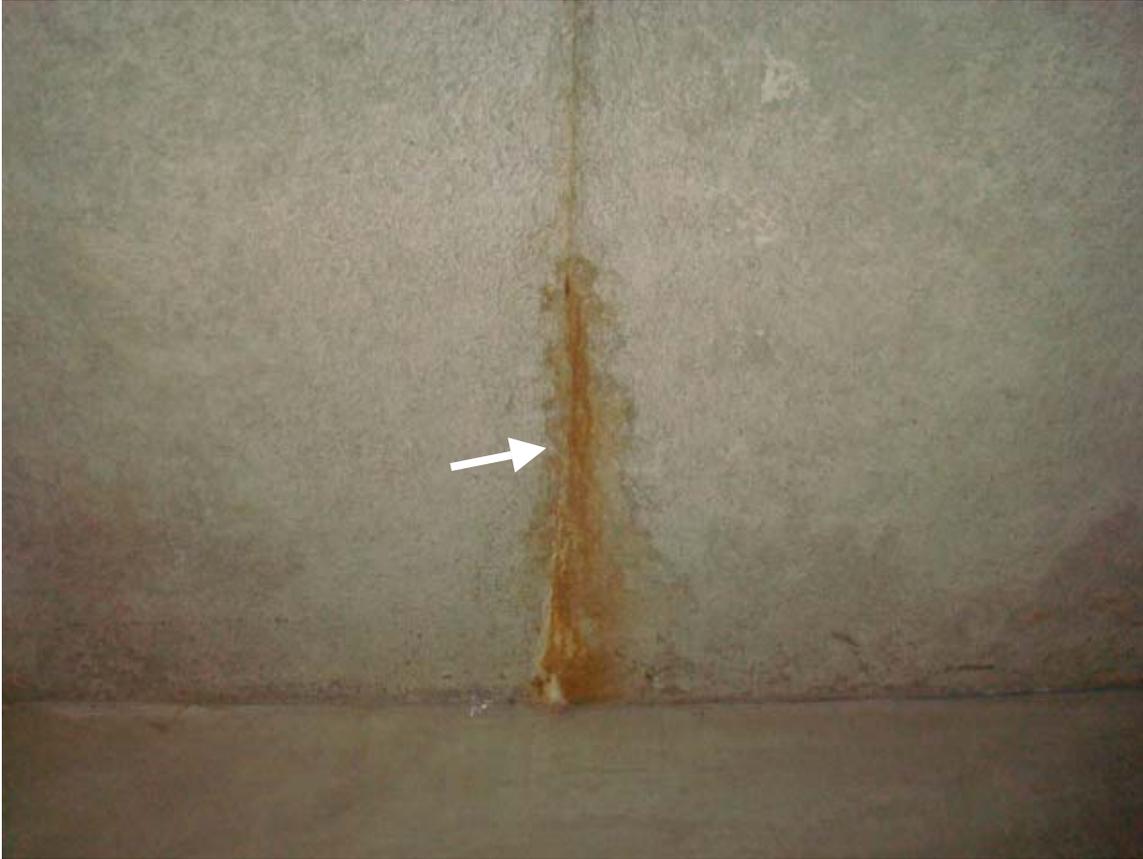
Poured concrete. Cracking and stains noted at the center rear basement wall . Due to the nature of the crack we recommend further review/repair by a foundation/crack repair contractor. (Epoxy repair)

Cracking and stains noted at the center rear basement wall . Due to the nature of the crack we recommend further review/repair by a foundation/crack repair contractor. (Epoxy repair)

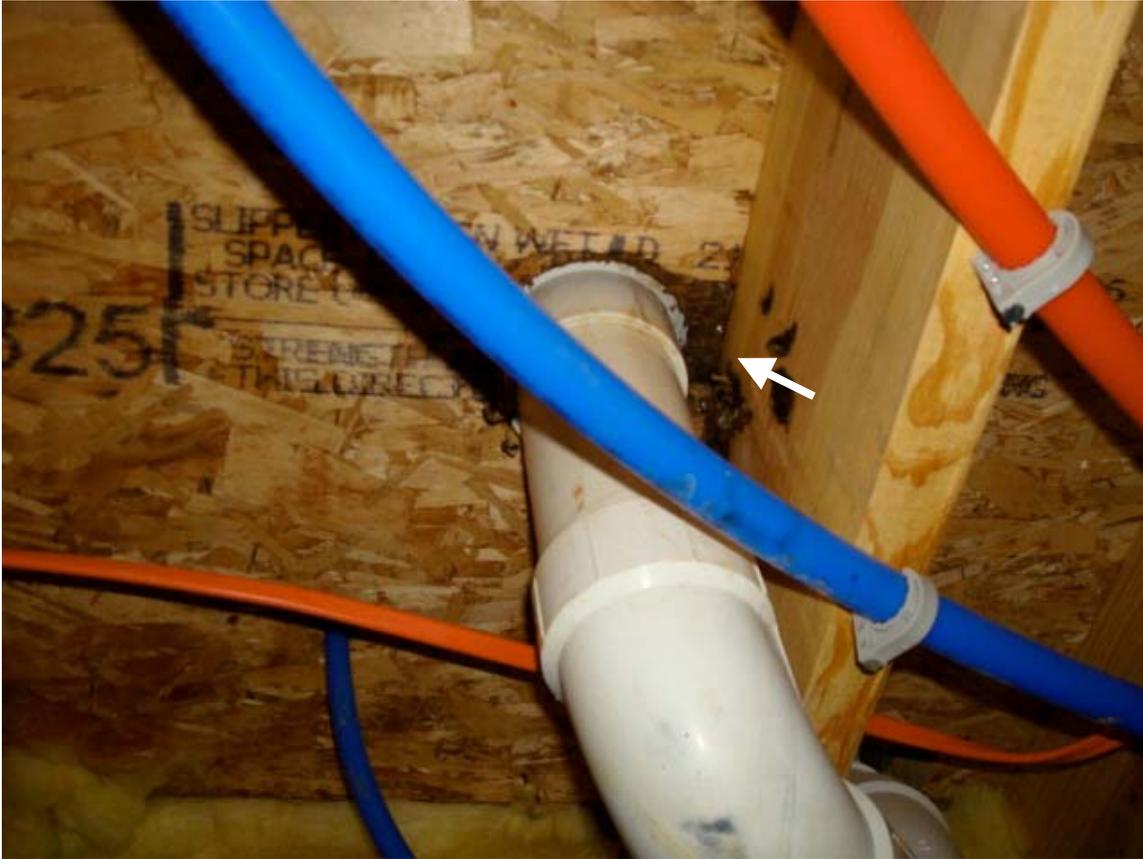
Deterioration of sub-floor noted around the leaking half bathroom toilet. Recommend review/repair as needed by a licensed contractor.

Deterioration of sub-floor noted around the leaking half bathroom toilet.
Recommend review/repair as needed by a licensed contractor.

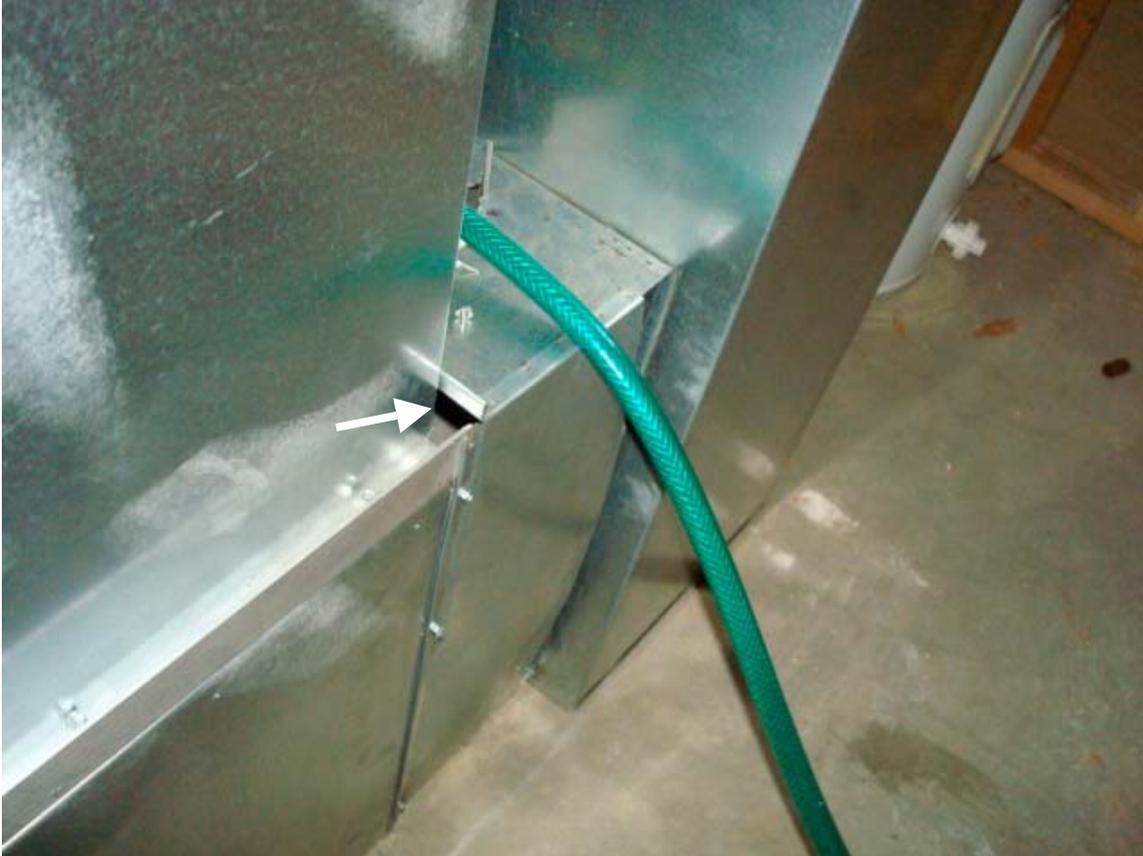
There is a gap in the duct near the filter, recommend covering the gap.

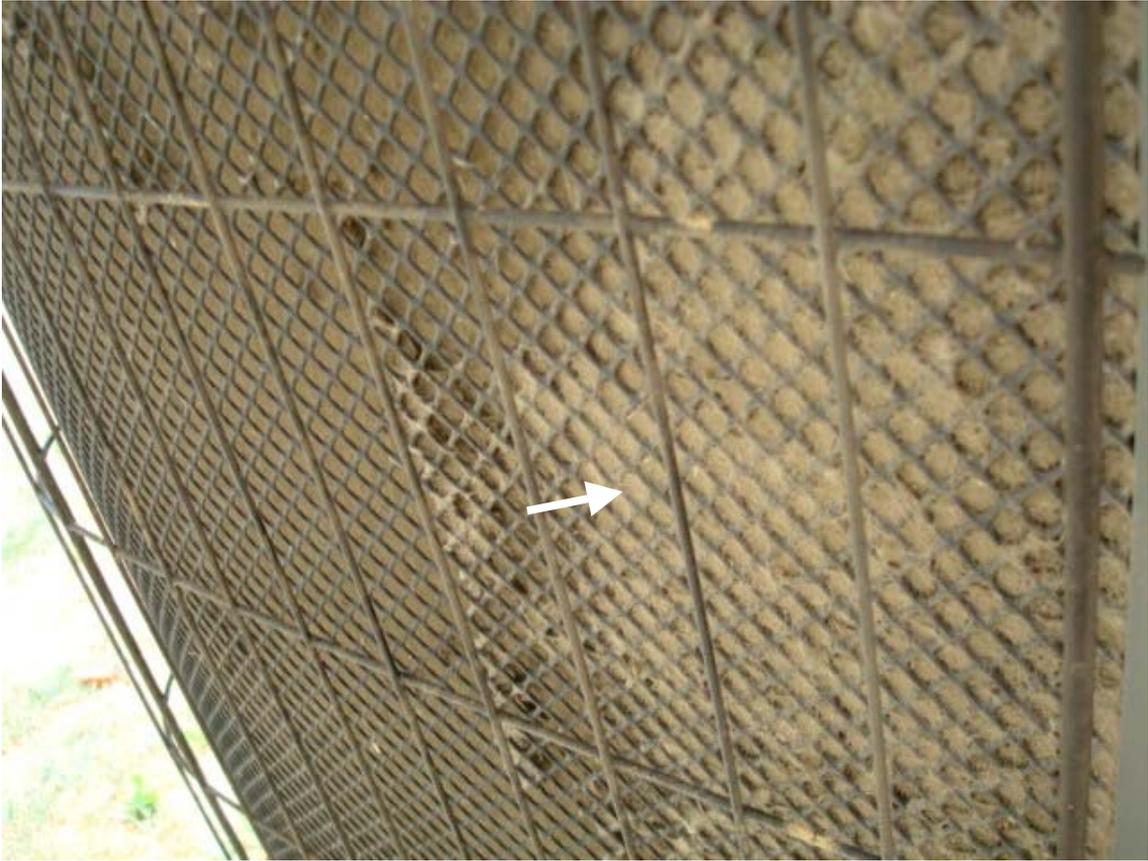
Operated. Temperature drop was 18 degrees, which is within the acceptable cooling range. The coils on the exterior AC unit are obstructed with dust and debris, recommend cleaning to ensure proper operation.

The coils on the exterior AC unit are obstructed with dust and debris, recommend cleaning to ensure proper operation.

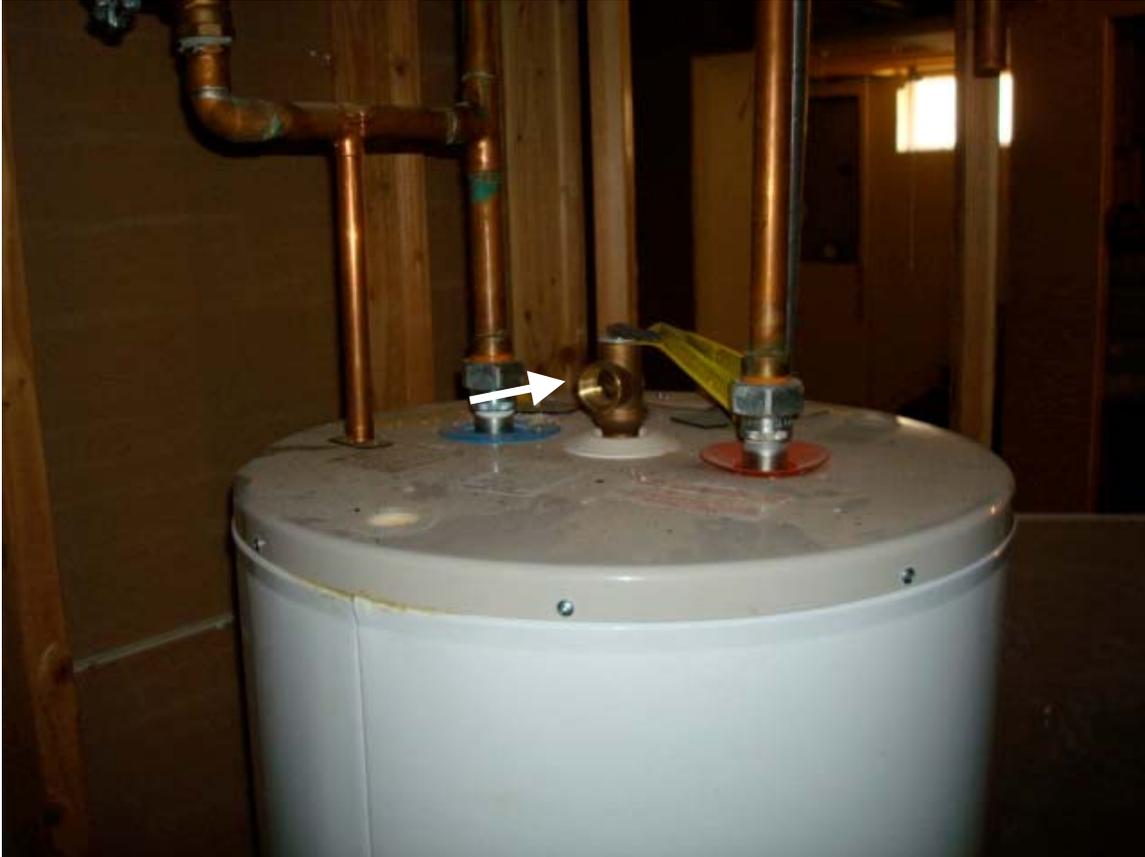
Located in basement. Capacity 50 gallons. Fuel: Electric. Cold water shutoff noted. TRP valve installed. TRP valve discharge line should be 3/4 inch diameter within 6 inches of ground.

TRP valve discharge line should be 3/4 inch diameter within 6 inches of ground.

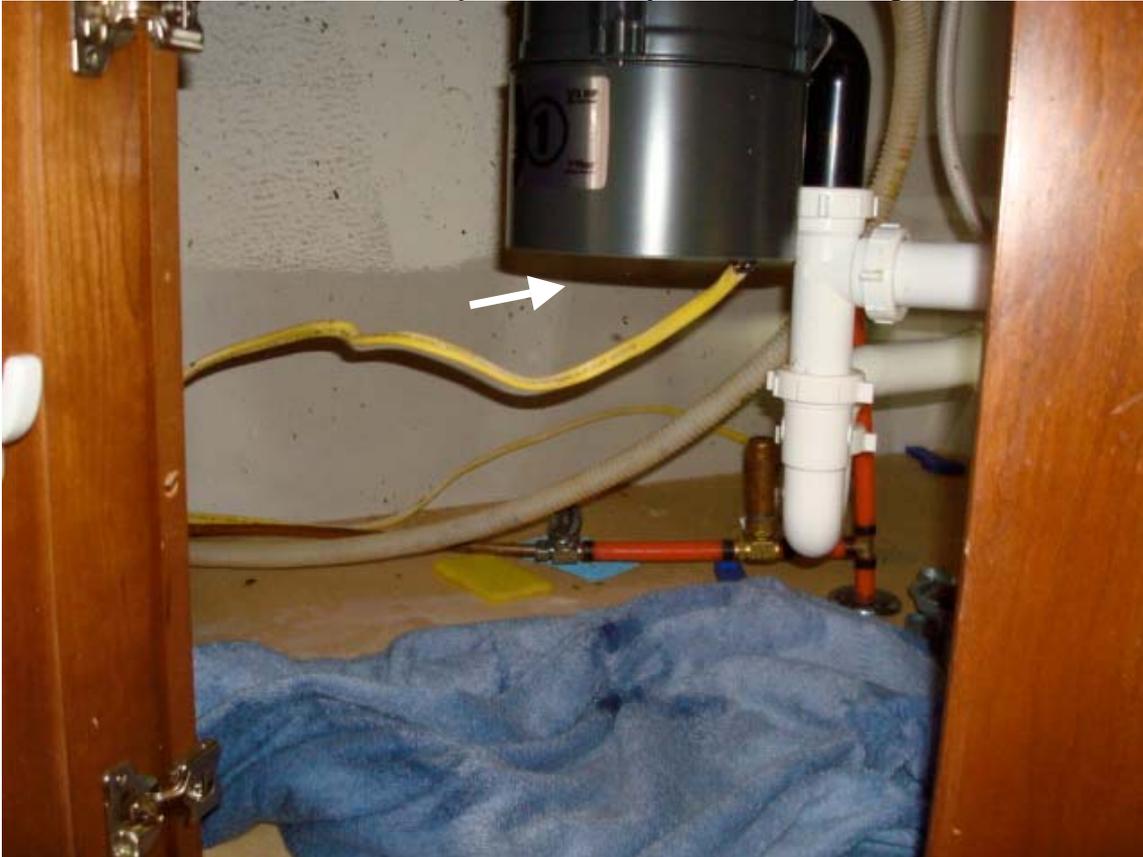
The disposal is leaking water. Recommend repair/replace as needed.
Recommend review/repair as needed by a licensed plumbing contractor.
