A.C.E. Home Inspection Service

Inspector Name: Tim Knight, ASHI Member 202490
Inspection No: 12121212
Inspection Date: 1/1/2012
Client: John Doe
Address: 1234 Sample Dr.
Sample, MO 61212

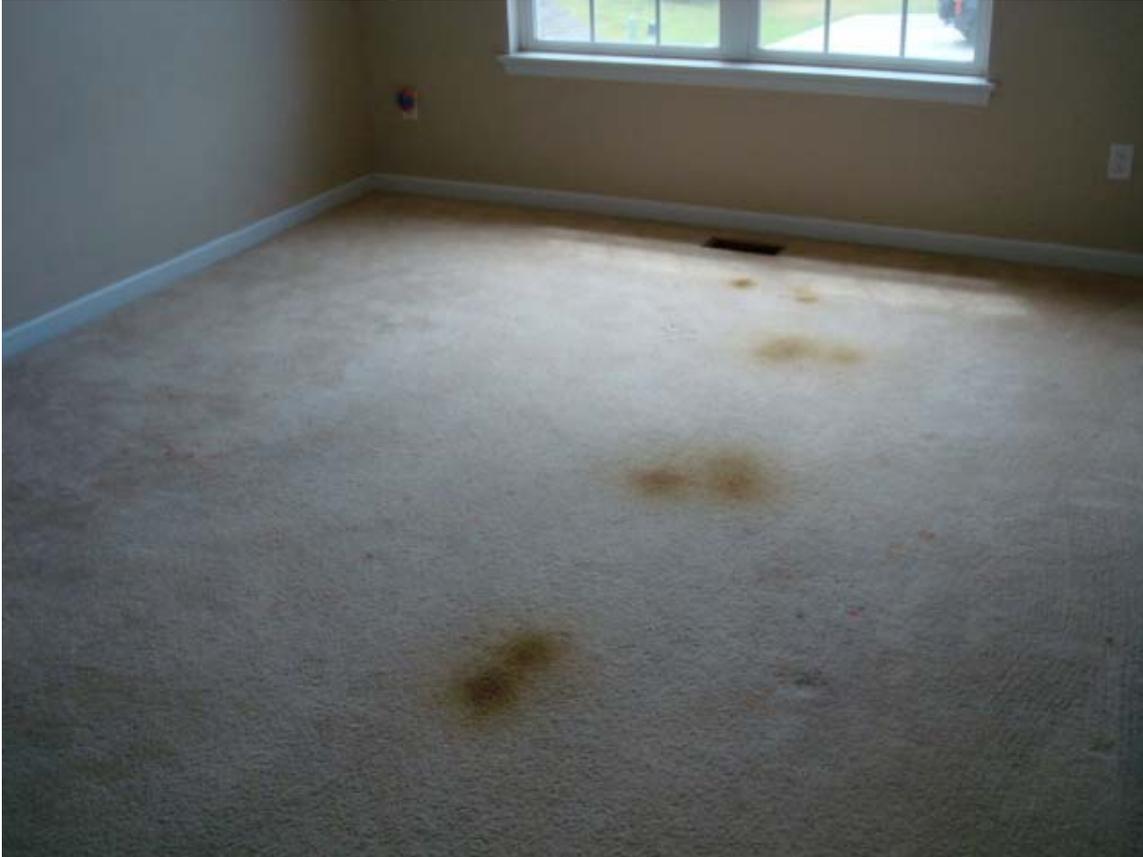
The carpet throughout the house is worn and stained.

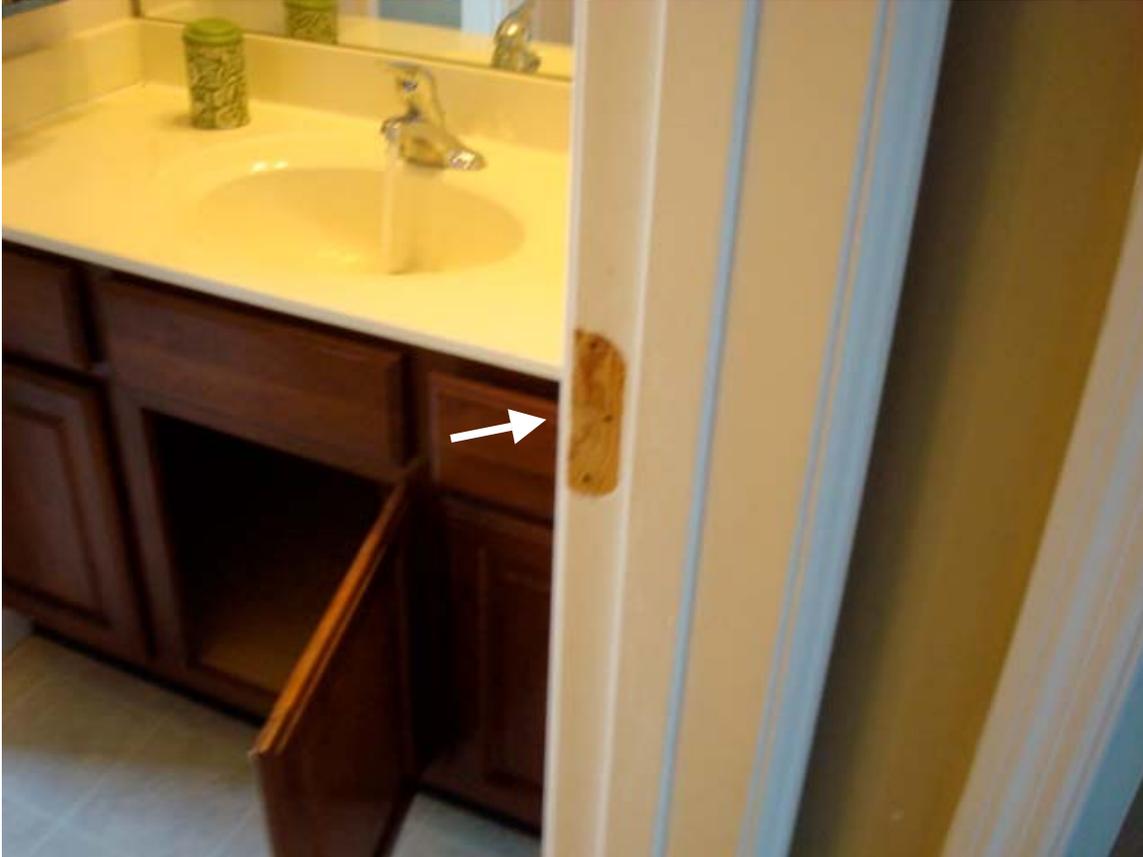
Recommend replacing the missing ball bathroom door.
